House 138

CASE STUDY

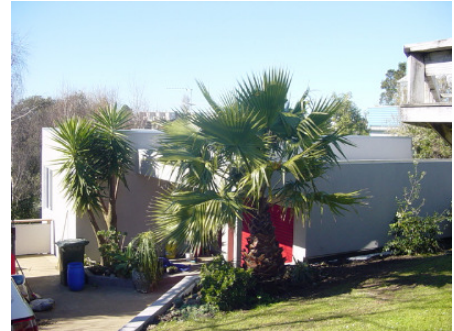
House 138 is a good example of how undetected leaks will rot treated timber given time. The building is a 15 years old parapet-detailed house with EIFS over treated timber. Costs for remedial have escalated to over \$200,000.

Treated timber does not stop the onset of decay – it only delays it.

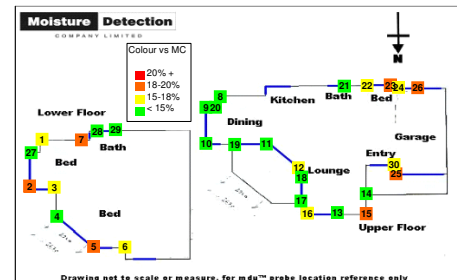
On assessment, Mdu Probe readings and drill samples taken highlighted issues with sections of walls with deteriorated internal scuppers, deck stop ends and window flashings.

The house is now reclad. Due to the replacement of extensive rot to the main structural timbers the house has become costly to fix. Internal finishing was also required.

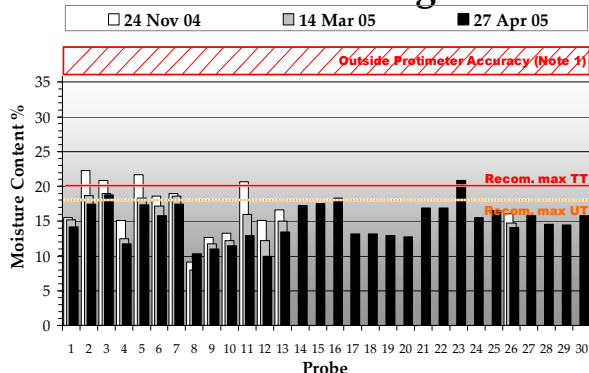
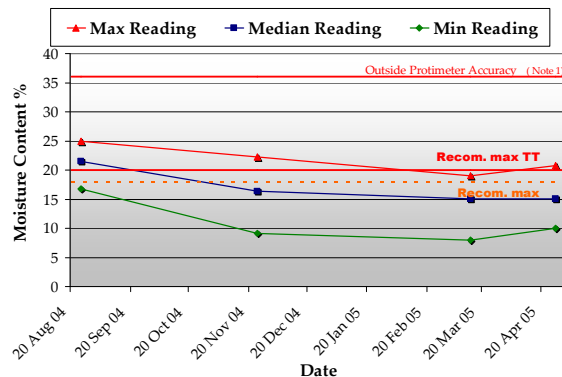
mdu™ Probe Readings

Monitoring with Mdu Probe readings show repairs have worked and the house is drying out. This case shows that treated timber will not stop rot – it merely delays it. One probe under the scuppers would have alerted the owners to a problem well before rot had set in.
