# What You Absolutely Must Know About Owning a Plaster-Clad Home

**The origin of New Zealand's leaky building crisis and must-know information for owners to make their homes weathertight, and regain lost value**

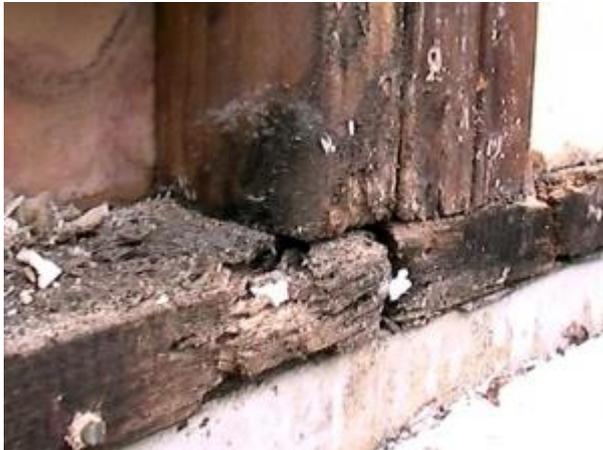
Typical rot seen in the bottom plate of a house built with untreated timber and no cavity

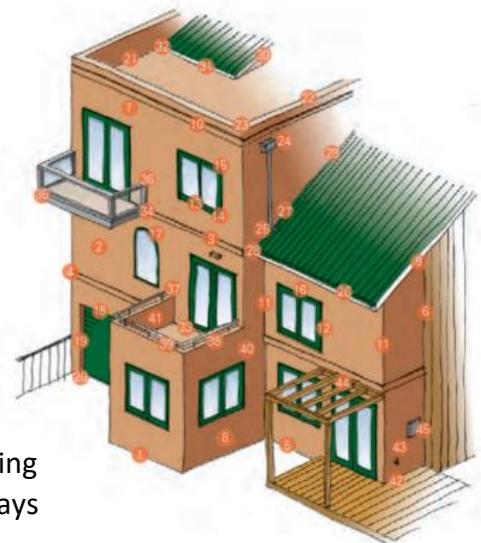
Typical features that add to the risk profile of a house include:

- Built in a high wind zone
- Built in a valley or shaded by trees
- Small or non-existent eaves
- Flat roofs
- Complex roofs with internal gutters
- Balconies
- No or inadequate control joints between sheets of cladding
- Windows with no or inadequate flashings or under sill trays
- Pergolas and verandas fixed through cladding
- Flashings without stop ends
- Flashings relying on sealants
- Curved or arched windows, round windows etc
- Not enough clearance between ground and cladding
- Taylor or Klass fascia style guttering
- Low pitch tile roofs without 'ponding boards'
- Plastic sill flashings embedded into plaster

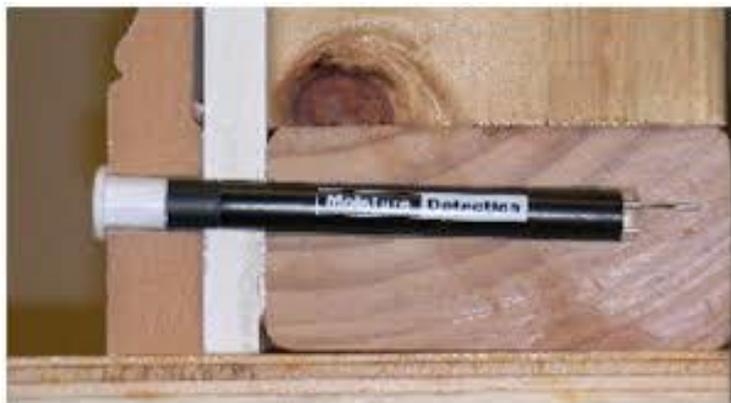
In 2004, *Moisture Detection Company* designed and patented their unique Moisture Detection Probes as part of a complete building condition, moisture monitoring and decay management system. The probes measure and monitor the moisture levels directly in the framing out near the external cladding. This is where leaks and decay are most likely to show up.

### Mdu Moisture Probe Installed Into the Bottom Plate for Accurate Measurements
